High Resolution Millimeter Wave Inspecting of the Orbiter Acreage Heat Tiles of the Space Shuttle

J.T. Case¹, S. Kharkovsky¹, R. Zoughi¹, and F. Hepburn²

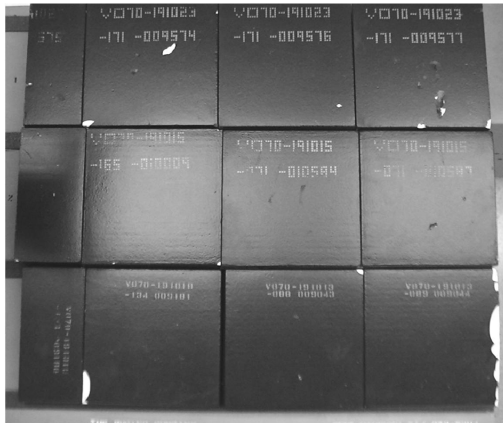
The first of two acreage heat tile specimens used in this investigation is shown in Figure 1a. It was composed of nine individual square tiles with an approximate area of 150 mm by 150 mm with varying thicknesses in the range of 15 mm to 30 mm (even within a given tile) and three rectangular tiles with an approximate area of 75 mm by 150 mm. Aluminum substrate of this specimen had two square and one rectangular thin pockets. Various anomalies representing thin debonds of different shapes and poor bonds between the tiles and substrate as well as circular repair regions inside the tiles were embedded in this specimen.

Figure 1. Picture of (a) first heat tile specimen with debonds and repairs and (b) second heat tile specimen with surface defect and corrosion.

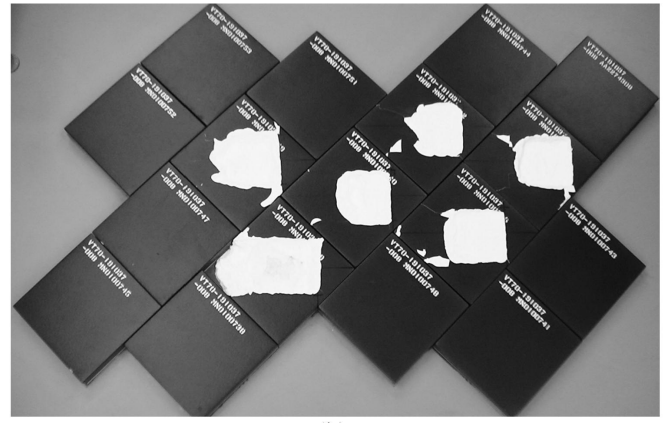
(b)

The second acreage heat tile specimen used in this investigation is shown in Figure 1b. It was composed of seventeen diagonally arranged individual square tiles with identical height and aggregate larger approximate area than the first specimen. Each tile measured approximately 150 by 150 mm. Here, one tile covered many small induced aluminum oxide corrosion pits in the aluminum substrate with various depth and size, six other tiles represented various shapes of surface defects as seen in white, and the remaining tiles represented no defect and no corrosion.

Figure 3 shows a slice of the hologram from the specimen shown in Figure 1b corresponding to the substrate viewed from above using Q-band (33-50 GHz) containing the region of interest. Surface defects in the heat tile are readily apparent. More interestingly, the tile covering an unknown number of corrosion pits in the far lower left corner of the image cannot mask the corrosion at millimeter wave frequencies, as shown in Figure 3. Eight of these indications were identified in the hologram. This sample also could not be dissected for interrogation since other additional inspection methods would be performed
